Maryland Historical Trust State Historic Sites Inventory Form

Survey No. BA-2754

1. Nan	1e (indicate pr	eferred name)		
historic				
and/or common	622 Anneslie Road			
2. Loca	ation		·	
street & number	622 Annesl	ie Road		_ not for publication
city, town	owson	vicinity of	congressional district	
state Ma	aryland	county	Baltimore

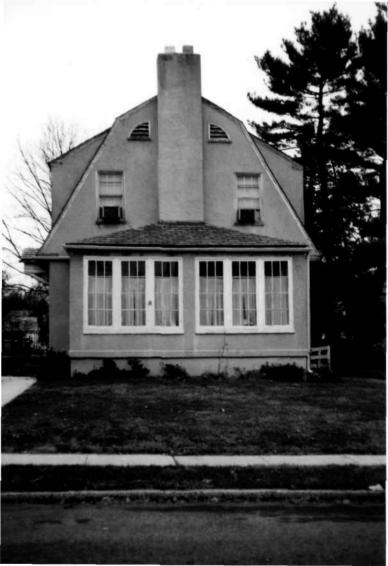
BA-2754 PHOTO 10F5 622 Annestie Road Baltimore County Maryland Photographer: Suzanne.

Noviember 27,1994 Location of Negative: Maryland SHPO View: South Focave. Facing Street PHOTO: 1 0F 5

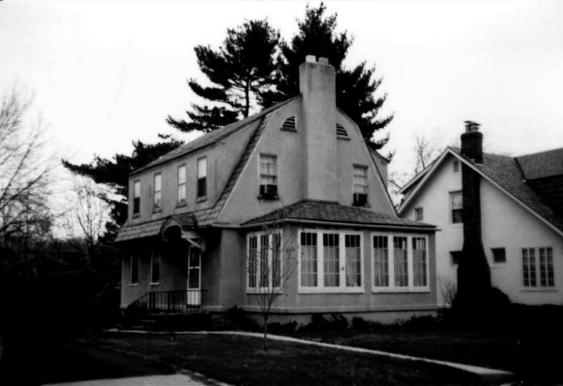
622 Anneslie Road BA-2754 Baltimore County Moreyand Photographer: Suzanne Mantegna Date taken: November 27,1994 Location of negotive: Maryland SHPO View: South and West FOCODE West Focuse-main entrance PNOto: 20F5

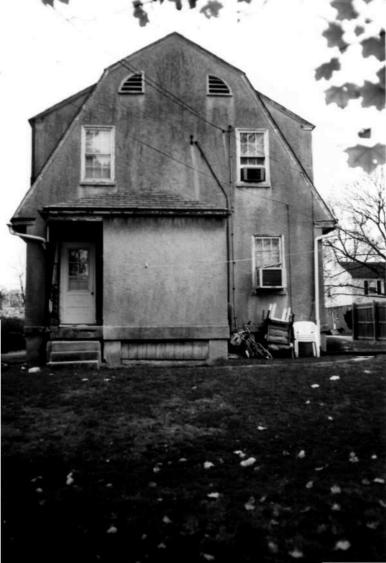
BA-2754 622 Armestre Rood Bartimore county Maryland Photographer: Suzanne Mantegna Date taken: November 27,1994 Location of negotive: Maryland SHPO View: North Focode (book of nonse) Photo: 30F5

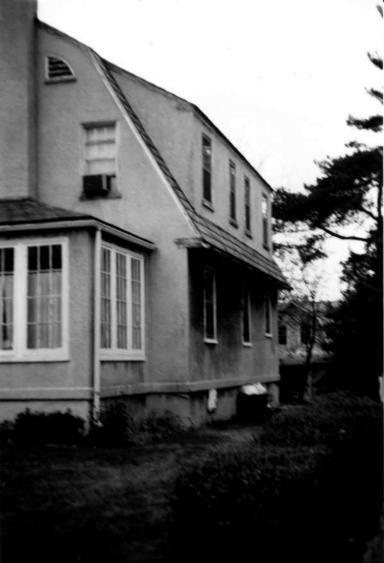
Photo: 4 of 5

622 Anne Slive Rood BA-2754 Boultimore County Maryland Photographer: Suzanne Mantegna Date taken: November 27, 19,94 LOCATION OF Negative: Maryland SHPO VIEW: Fart of South, and East Foxable

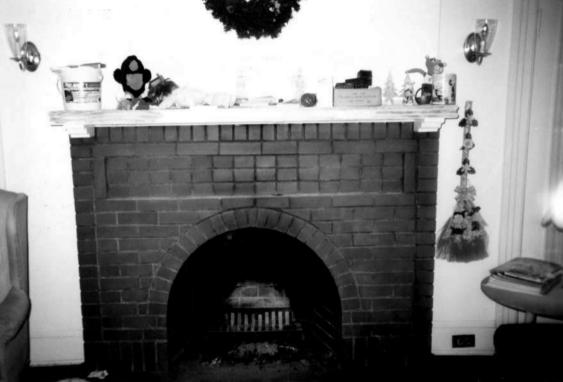
622 Annestie, Road BA-2754 Baltimore courty Manybard Photographer: Suzanne Mantegna Date taken: November 27,1994 Location of negative: Maryland SHPO View: Living Room Interior Fire Pace & mouthe Photo: 50F5
